# South Pond – History and Investigative Summary, Occidental Chemical Company Plant Site, Ludington, Michigan

PREPARED FOR: Denny Huggard/The Dow Chemical Company

PREPARED BY: CH2M HILL

DATE: May 8, 2014

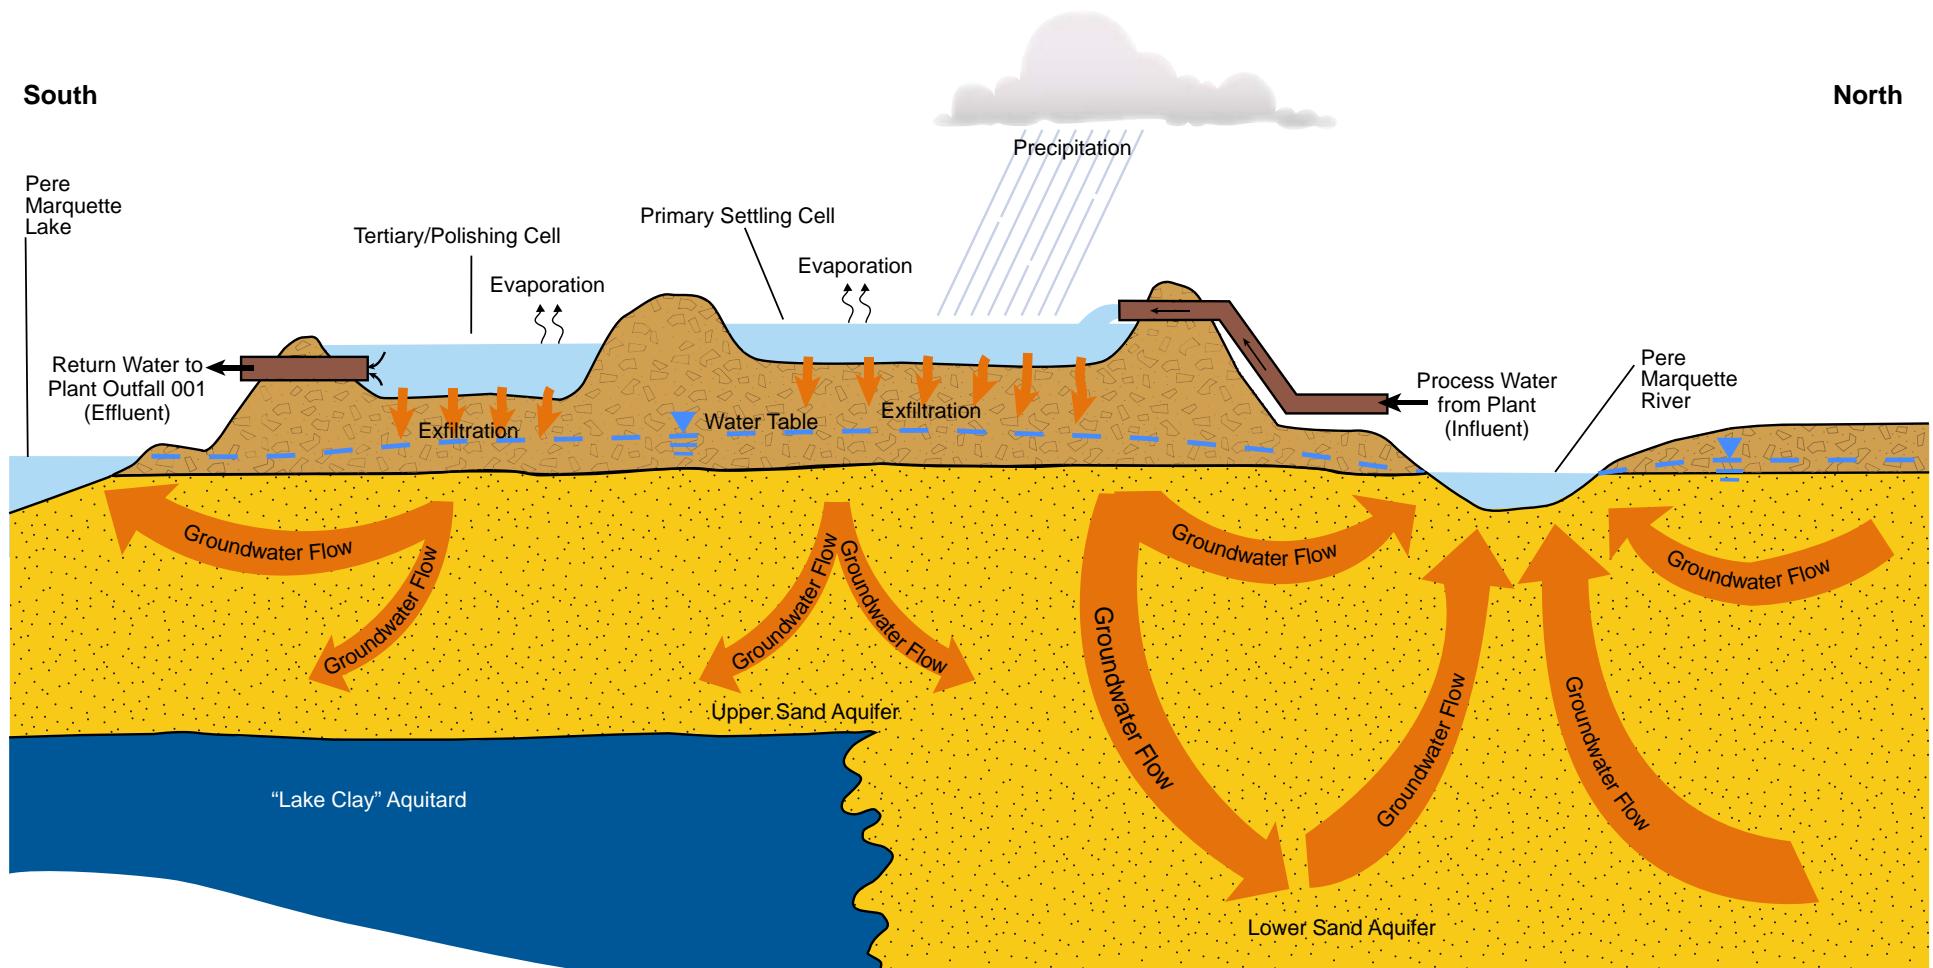
Figure 7

- [Brown Pattern] Non-Native Fill
- [Yellow Dots] Upper or Lower Sand Aquifer
- [Blue Solid] "Lake Clay" Aquitard

Conceptual Site Model  
South Pond - History and Investigative Summary  
Ludington Plant Site  
*The Dow Chemical Company*  
Ludington, MI

In 2012, a third phase of the exfiltration study was executed. This phase was tasked with determining if exfiltration water from the South Pond is migrating to areas beyond the Pere Marquette River and Pere Marquette Lake, and to further understand the fate of groundwater beneath the ponds that is affected by exfiltration losses. This was accomplished by employing a variety of hydraulic measurement tools. Seven additional monitoring wells (shallow and deep) were installed on the northern side of the Pere Marquette River (Figure 8). Hydraulic pressure differential measurements were collected in Pere Marquette River and Pere Marquette Lake around the perimeter of the South Pond to identify potential areas of groundwater seepage. Based on these results, seepage meters were deployed to quantify the rates of groundwater seepage to surface water. Phase III concluded that shallow and deep groundwater on the northern side of the South Pond discharges to Pere Marquette River and Pere Marquette Lake and that hydraulic pressure differential and seepage measurements confirmed groundwater is venting to surface water. Ultimately, these lines of evidence indicate exfiltration water from the pond system cannot be migrating beyond Pere Marquette River and Pere Marquette Lake (CH2M HILL 2012). Figure 9 presents the general understanding of the conceptual site model following Phases I, II, and III of the exfiltration study.
